OSHA FALL PROTECTION TEST REPORT

VELUX AMERICA INC.

SERIES/MODEL: CAP-1 PRODUCT TYPE: Fixed Acrylic Glazed Skylight

Report No: 90197.01-109-44
Test Date: 04/01/09
Report Date: 10/20/09
Record Retention Date: 04/01/13

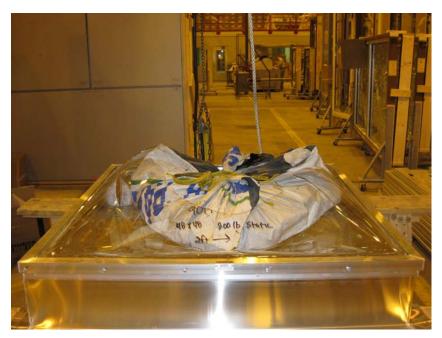
Note #1: At the 42" drop height, the exterior dome broke and testing ceased.

Photo No. 2 Test Specimen #1 (48 x 48) Failure
