**OSHA FALL PROTECTION TEST REPORT**

**VELUX AMERICA INC.**

**SERIES/MODEL: CM**

**Report No: 88220.01-109-44**

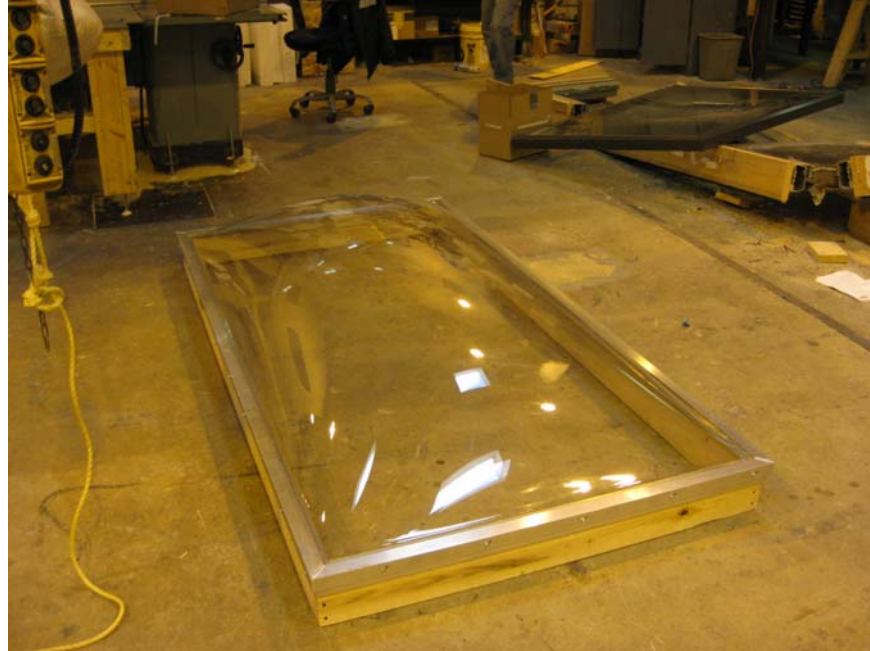
<u>Test Method</u>	<u>Load Location</u>	<u>Results</u>
OSHA Safety Test		
200 lbf	Center of dome	No visible damage

**Photo No. 1**  
**48 x 96 Acrylic Glazed Skylight Before Testing**

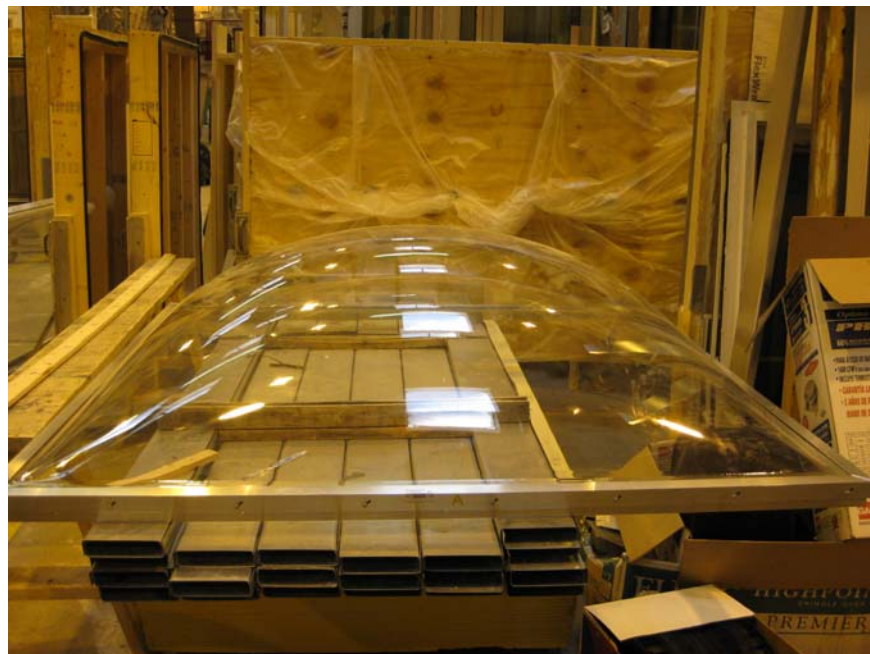
OSHA Safety Test		
200 lbf	Center of dome	No visible damage

**Photo No. 2**  
**72 x 72 Acrylic Glazed Skylight Before Testing**
