OSHA FALL PROTECTION TEST REPORT

VELUX AMERICA INC.

SERIES/MODEL: CAP-1 PRODUCT TYPE: Fixed Polycarbonate/Acrylic Glazed Skylight

Report No: 90198.01-109-44
Test Date: 04/01/09
Report Date: 10/20/09
Record Retention Date: 04/01/13

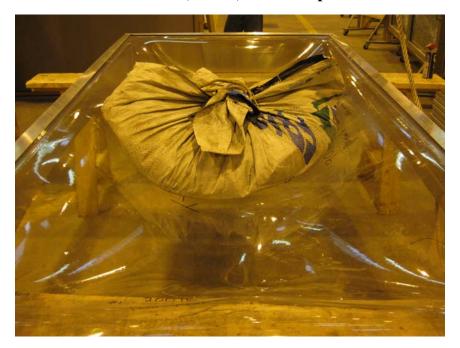
Note #1: At the 8' drop height, the exterior dome permanently deformed and the interior dome broke. The weight did not fall through the skylight.

Photo No. 2 CAP-1 (48 x 96) Impactor Fell Through Exterior Glazing Sheet
