### **OSHA FALL PROTECTION TEST REPORT**

## VELUX AMERICA INC.

SERIES/MODEL: CAP-1 PRODUCT TYPE: Fixed Polycarbonate/Acrylic Glazed Skylight

Report No:
 90199.01-109-44

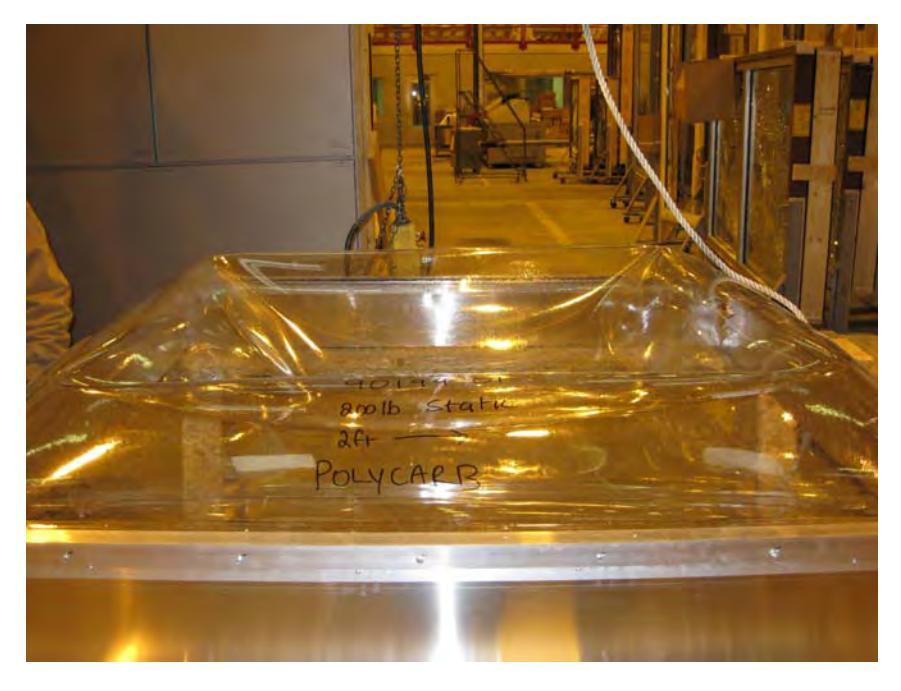
Photo No. 2 CAP-1 (72 x 72) Failure

*Note #1*: At the 2' drop height, the exterior dome permanently deformed and the interior dome broke. The weight did not fall through the skylight.
