VELUX America LLC TEST REPORT

OSHA FALL PROTECTION TESTING ON CD2/CE2 SKYLIGHT

H5831.01-109-44

Product Type: Skylight
Series/Model: CD2/ CE2

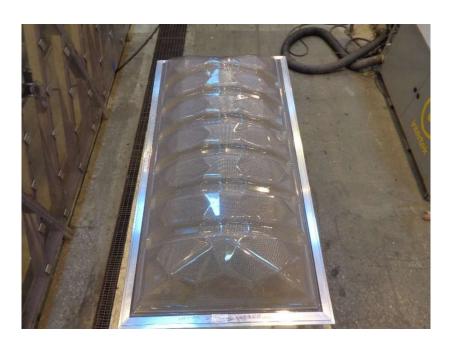
Photo No. 1 View of Tested Specimen

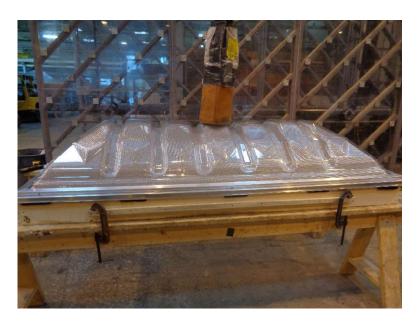
Observations: The 400 lbf weight was gently applied perpendicular to the center of each dome; after 60 seconds of rest time, there was no visible damage to the skylight.

Photo No. 2 View of Tested Specimen with 400 lbs Applied
