**ASTM E 90 SOUND TRANSMISSION LOSS  
TEST REPORT**

**VELUX AMERICA INC.**

**SERIES/MODEL: FCM 4646 0006**

**TYPE: Fixed Curb Mounted Skylight**

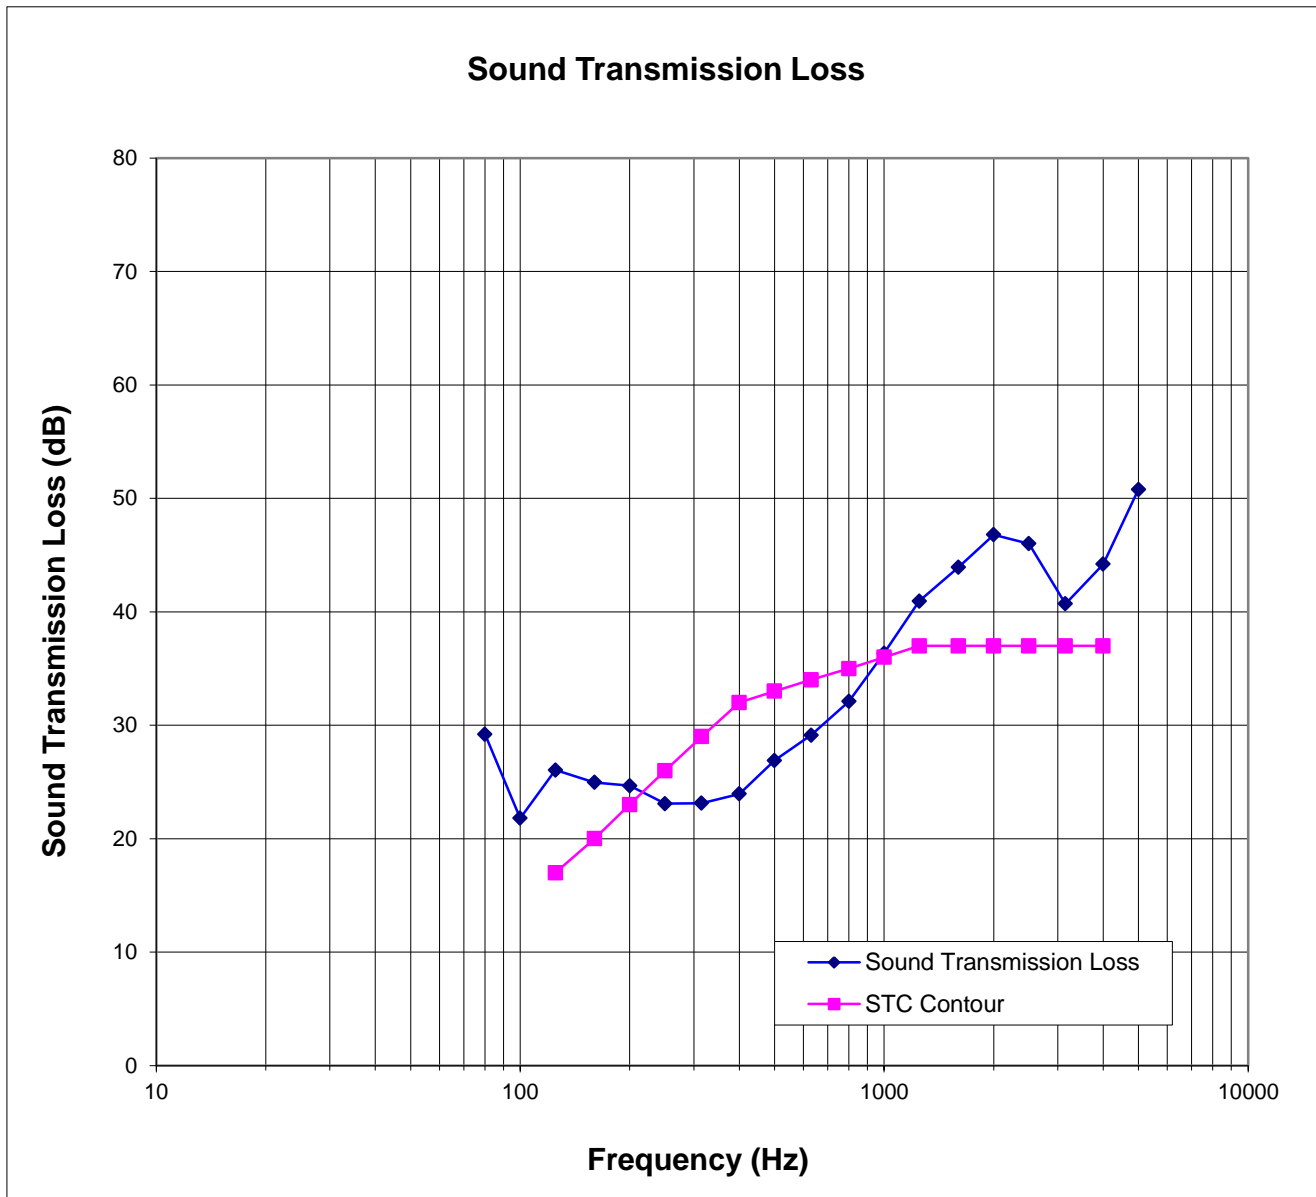
ATI No. B0238.01 Date 06/10/11  
Client VELUX America Inc.  
Specimen Series/Model: FCM 4646 0006, fixed curb mounted skylight with 23/32" IG (5/32" tempered exterior, 5/16" argon, 1/4" laminated interior), Glass temperature 75°F  
Specimen Area 1.69 Square Meters  
Filler Area 11.30 Square Meters  
Operator Daniel P. Platts

**STC Rating = 33**      *(Sound Transmission Class)*  
**Deficiencies = 31**      *(Number of deficiencies versus contour curve)*  
**OITC Rating = 28**      *(Outdoor/Indoor Transmission Class)*

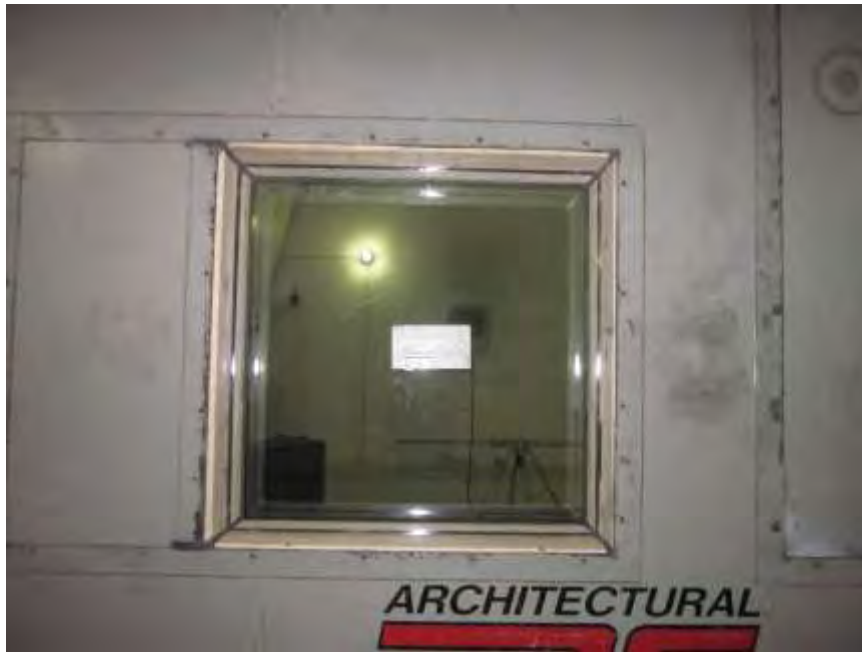
**Receive Room View of Installed Specimen**

The 72" by 48" plug was removed from the filler wall assembly and a 24" by 48" filler wall, reducing element was installed. The reducing element utilized the same construction as the filler wall. A split 2x6 wood frame was placed into the 48" by 48" opening. A dense neoprene gasket and duct seal were used to seal the wood frame to the inside perimeter of the filler wall opening. The test specimen was then fastened to the exterior of the wood frame opening with drywall screws. Duct seal was used to seal the skylight perimeter to the wood frame on both sides. The interior side of the skylight frame, when installed was flush with the source room side of the filler wall. A stethoscope was used to check for any abnormal air leaks before the test.

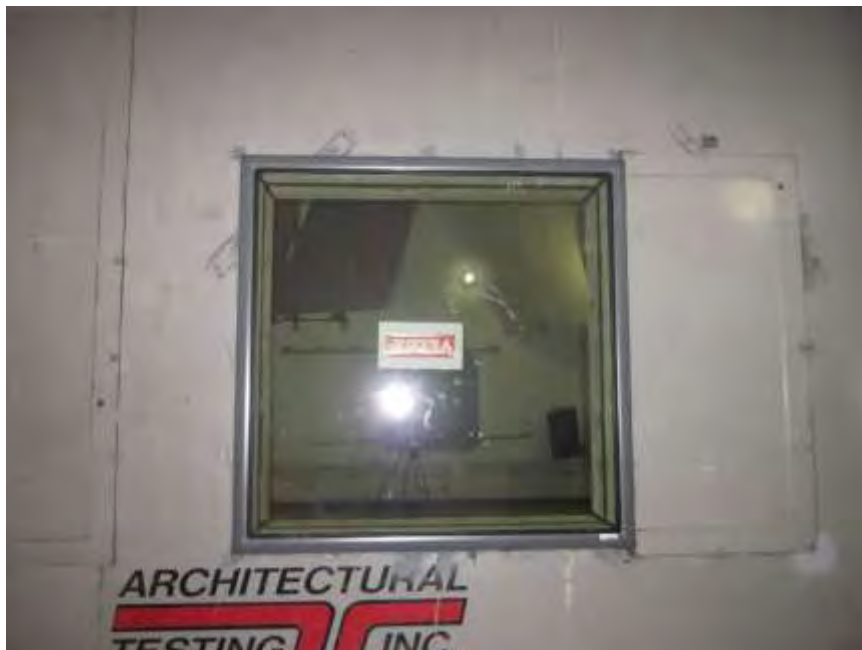
**Source Room View of Installed Specimen**
