TEST REPORT

Report No.: G2786.01-109-44

PRODUCT TYPE: Fixed Curb Mount Skylight

SERIES/MODEL: "Specials" Single Dome Skylight Acrylic Smooth (5' x 8') (0.150 thickness)

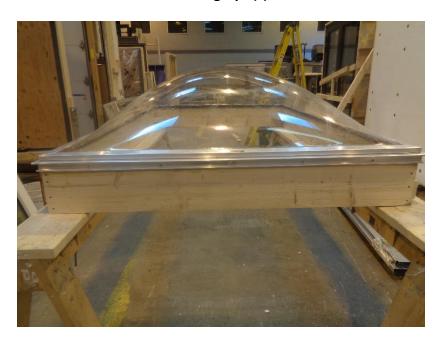
Photo No. 1 Tested Specimen

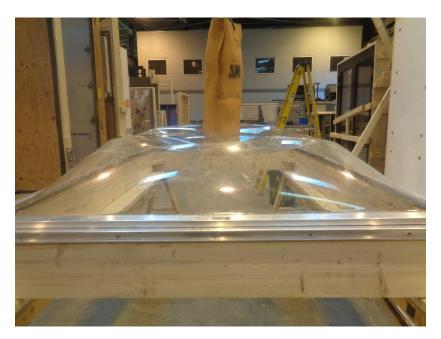
Photo No. 2
Tested Specimen with 400 lb. Load Applied

A 400 lb. weight, fabricated from a bag filled with lead shot, was placed on the center of the glazing for a minimum of 60 seconds. The bag was removed and the test unit was inspected for any signs of damage or failure.

Test Load	Load Location	Results
400 lb.	Center of dome	No visible damage

Note: Interior glazing was cut out prior to testing. The 400 lb. weight was applied perpendicular to the center of the dome. After 60 seconds of rest time, there was no visible damage to the glazing.
