TEST REPORT

Report No.: G4206.01-109-44

PRODUCT TYPE: Skylight with Curb **SERIES/MODEL**: Specials Dome Skylight 0.150 Thickness 100% IMA Smooth/0.118 Thickness 50% IMA Prismatic (5' x 8') with CCAM Curb

SPECIFICATION(S): Occupational Safety and Health Administration/U.S. Department of Labor Regulations (Standards- 29 CFR) - 1910.23(e) (8)

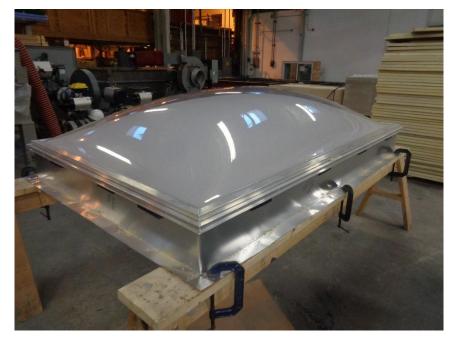
Photo No. 1 View of Tested Specimen

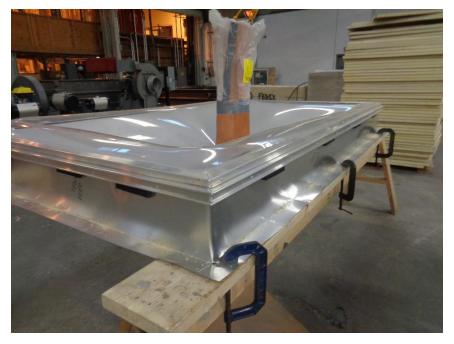
Photo No. 2 View of Tested Specimen with 400 lb Load Applied

A 400 lb weight, fabricated from a bag filled with lead shot, was placed on the center of the dome for a minimum of 60 seconds. The bag was removed and the test unit was inspected for any signs of damage or failure.

Note: The 400 lb weight was gently applied perpendicular to the center of the dome. After 60 seconds of rest time, there was no visible damage to the glazing.
