TEST REPORT

Report No.: G2784.01-109-44

PRODUCT TYPE: Fixed Curb-Mount Skylight

SERIES/MODEL: "SoCal" Dynamic Polycarbonate Dome (0.118")

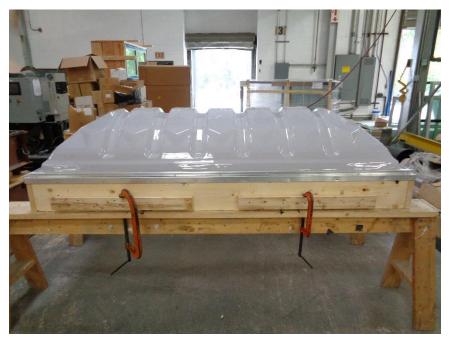
Photo No. 1 View of Test Specimen

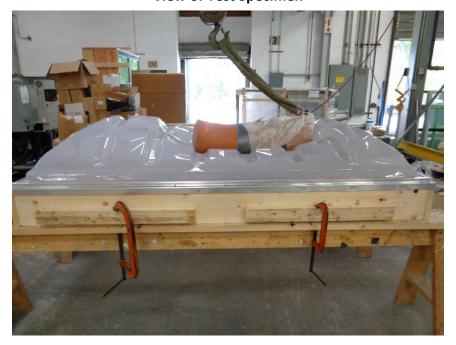
Photo No. 2
Test Specimen with 400 lb. Weight Applied

A 400 lb. weight, fabricated from a bag filled with lead shot, was placed on the center of the glazing for a minimum of 60 seconds. The bag was removed and the test unit was inspected for any signs of damage or failure.

Note: The 400 lb. weight was applied perpendicular to the center of each dome. After 60 seconds of rest time, there was no visible damage to the exterior glazing.
