### **TEST REPORT**

**Report No**.: G4124.02-109-44

**PRODUCT TYPE**: Sun Tunnel Skylight **SERIES/MODEL**: TCC 022

**SPECIFICATION(S)**: Occupational Safety and Health Administration/U.S. Department of Labor Regulations (Standards- 29 CFR) - 1910.23(e) (8)

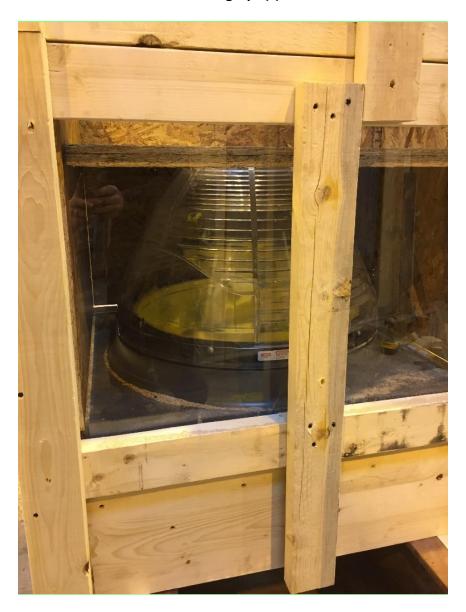
Photo No. 1 The Test Specimen

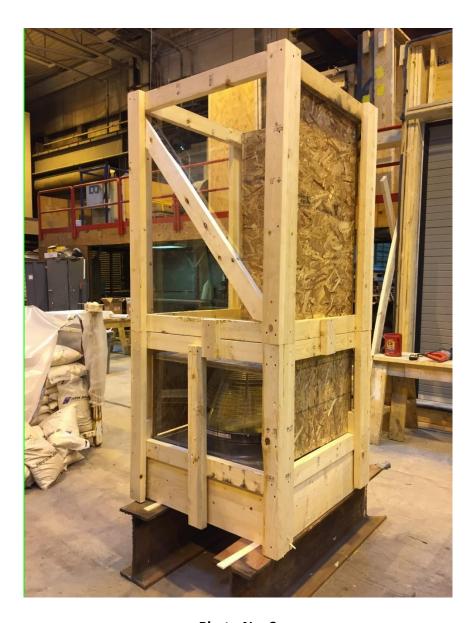
Photo No. 2 The Test Set-up

A 400 lb. weight, fabricated from a bag filled with lead shot, was placed on the center of the dome for a minimum of 60 seconds. The bag was removed and the test unit was inspected for any signs of damage or failure.
