## **TEST REPORT**

Report No.: G4212.01-109-44

**PRODUCT TYPE**: Skylight with Curb **SERIES/MODEL**: Specials Dome Skylight 0.118 thickness PC smooth/0.118 thickness PC smooth white (6' x 6') with CCAM Curb

**SPECIFICATION(S)**: Occupational Safety and Health Administration/U.S. Department of Labor Regulations (Standards- 29 CFR) - 1910.23(e) (8)

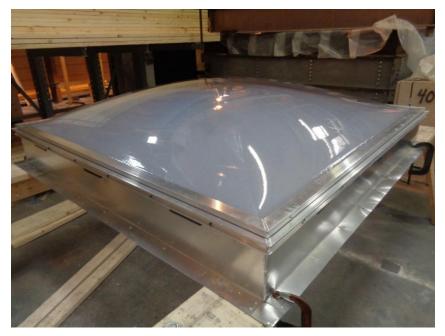
Photo No. 1 View of Tested Specimen

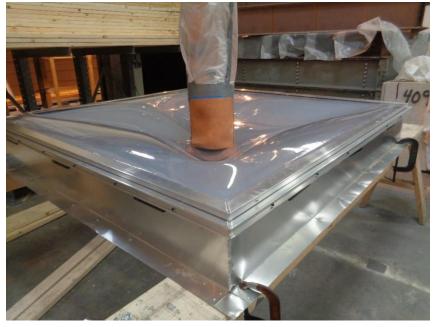
Photo No. 2 View of Tested Specimen with 400 lb Load Applied

A 400 lb. weight, fabricated from a bag filled with lead shot, was placed on the center of the dome for a minimum of 60 seconds. The bag was removed and the test unit was inspected for any signs of damage or failure.

Test Load	Load Location	Results
400 lb	Center of dome	No visible damage

*Note*: The 400 lb weight was gently applied perpendicular to the center of the dome. After 60 seconds of rest time, there was no visible damage to the glazing.
