#### **TEST REPORT**

**Report No.**: G4124.01-109-44

**PRODUCT TYPE**: Sun Tunnel Skylight **SERIES/MODEL**: TCC 022

**SPECIFICATION(S)**: Occupational Safety and Health Administration/U.S. Department of Labor Regulations (Standards- 29 CFR) - 1910.23(e) (8)

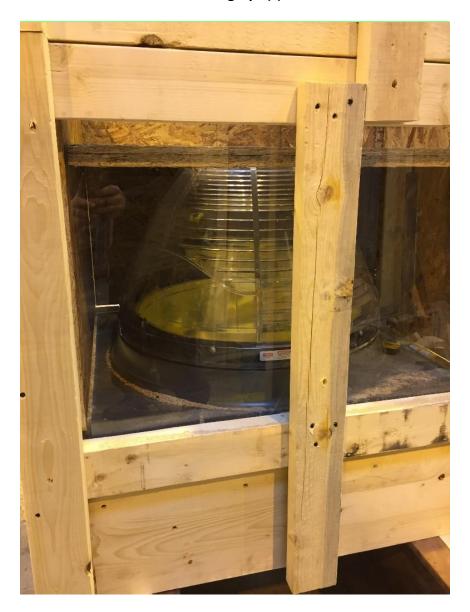
Photo No. 1 The Test Specimen

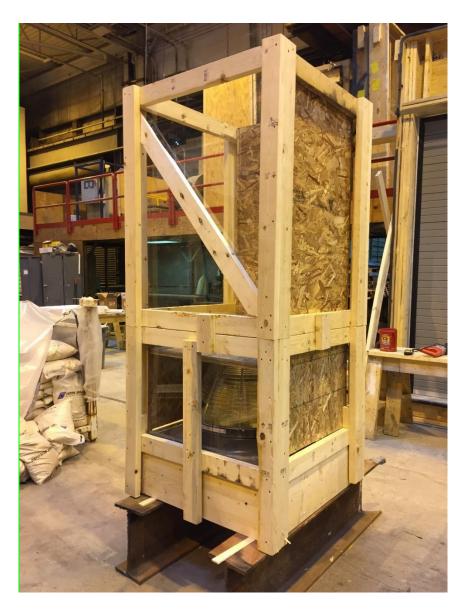
Photo No. 2 The Test Set-up

A 400 lb. weight, fabricated from a bag filled with lead shot, was placed on the center of the dome for a minimum of 60 seconds. The bag was removed and the test unit was inspected for any signs of damage or failure.
