TEST REPORT

Report No.: G4208.01-109-44

PRODUCT TYPE: Skylight with Curb

SERIES/MODEL: Specials Dome Skylight 0.118 Thickness PC Smooth/0.118 Thickness PC

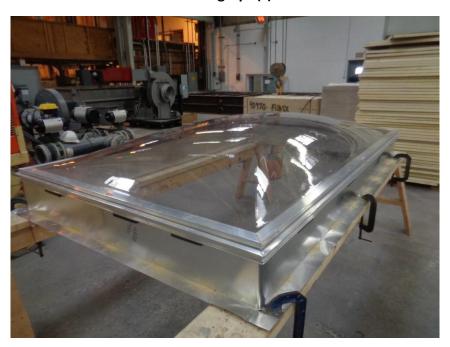
Photo No. 1 View of Tested Specimen

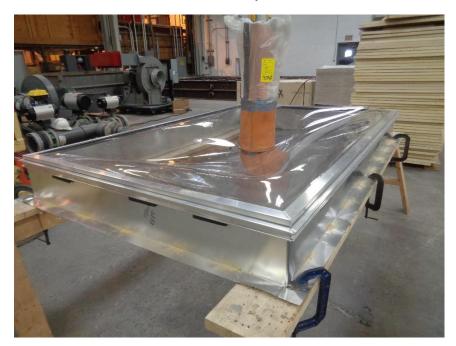
Photo No. 2
View of Tested Specimen with 400 lb Load Applied

A 400 lb weight, fabricated from a bag filled with lead shot, was placed on the center of the dome for a minimum of 60 seconds. The bag was removed and the test unit was inspected for any signs of damage or failure.

Test Load	Load Location	Results
400 lb	Center of dome	No visible damage

Note: The 400 lb. weight was gently applied perpendicular to the center of the dome. After 60 seconds of rest time, there was no visible damage to the glazing.
