TEST REPORT

Report No.: F8972.02-109-44

PRODUCT TYPE: Welded Wire Mesh **SERIES/MODEL**: 6' x 10' Accessory Tray with Safety Screen

SPECIFICATION(S): Occupational Safety and Health Administration/U.S. Department of Labor Regulations (Standards- 29 CFR) - 1910.23(e) (8)

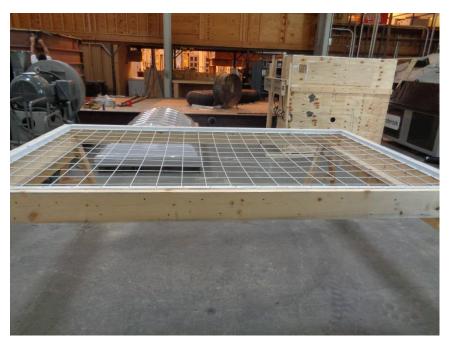
Photo No. 1
Accessory Tray with Safety Screen

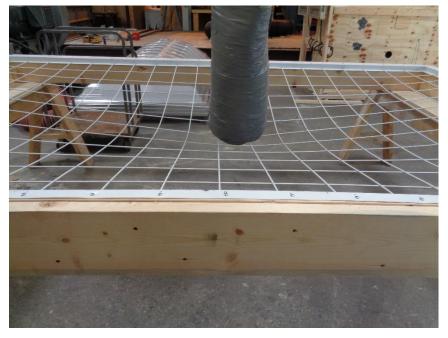
Photo No. 2
Test Specimen during 400 lb. Load

A 400 lb. weight, fabricated from a bag filled with lead shot, was placed on the center of the screen for a minimum of 60 seconds. The bag was removed and the test unit was inspected for any signs of damage or failure.

Note: The 400 lbf weight was applied perpendicular to the center of the screen. After 60 seconds of rest time, there was no visible damage to the screen. There was no curb deflection observed.

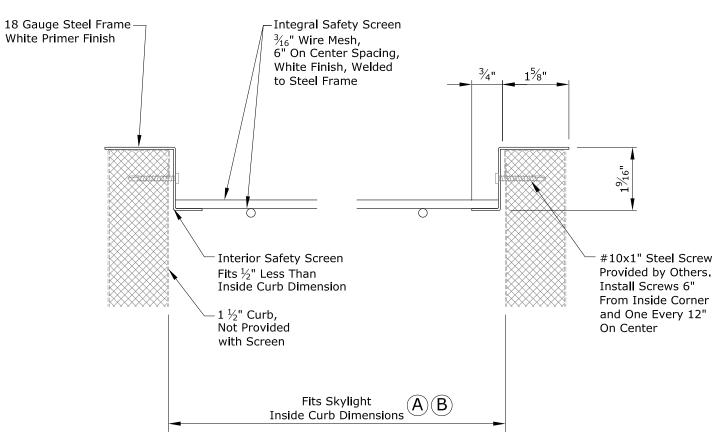
INTERIOR SAFETY SCREEN ACCESSORY (CRGA-ICD) CROSS SECTION

Interior Safety Screen Accessory (CRGA-ICD)

Interior Safety Screen Measurements

- (A) Width
- B Length
